TENSILE CRACK EXPOSURE TESTS

Report 3

LABORATORY EVALUATION OF SERIES "A" BEAMS
WITH RESULTS FROM 1951 TO 1975

Edward F. O'Neil

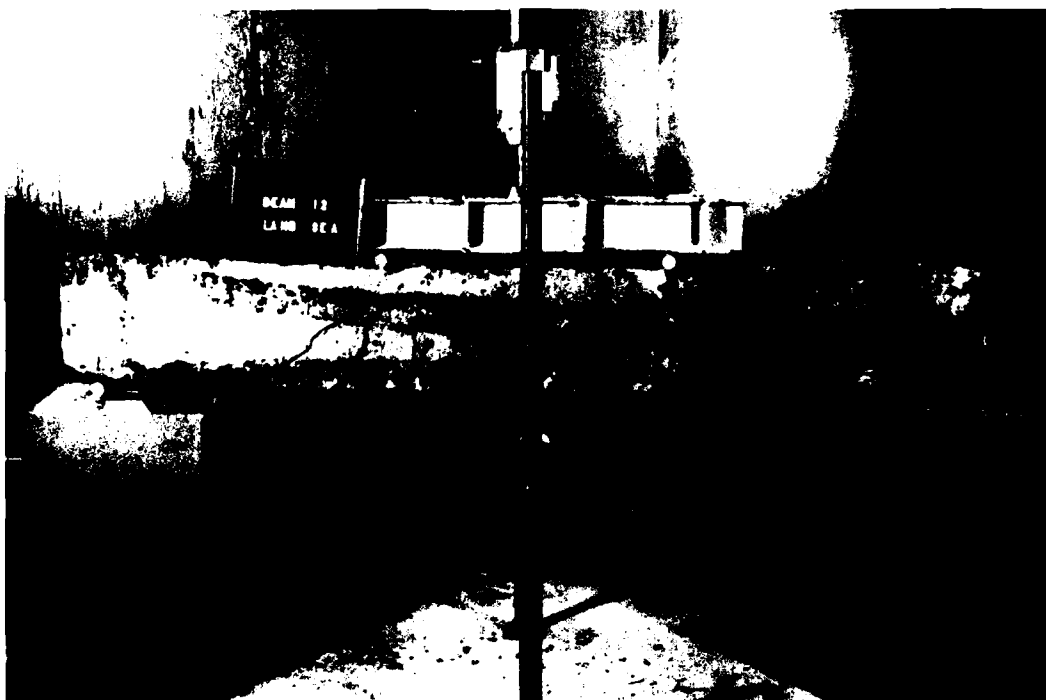
Figure 3. Failure testing configuration

22. The beams returned to the WES for study were tested to failure in the apparatus shown in Figure 3. They were loaded in third-point flexural loading similar to that used during the exposure period. The ram is a 60-ton hydraulic ram supplied by an electrical hydraulic pump. Selected sections of the reinforcing bars were tensioned tested to failure in the 440,000-lb universal testing machine.

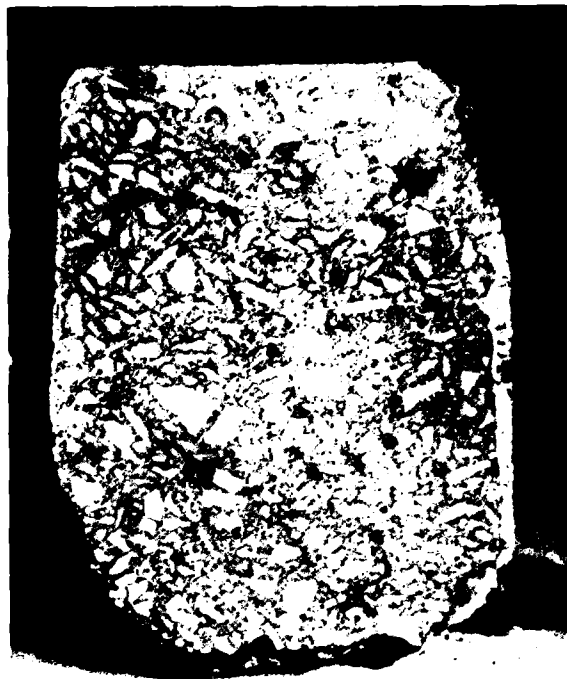
Photo 1. Section of 10-in.-wide beam
treated for depth of carbonation

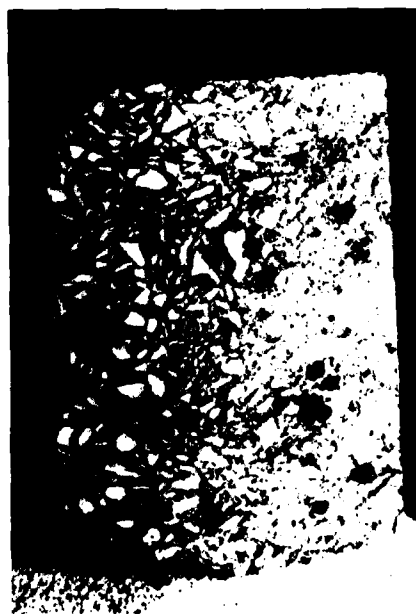
Photo 2. Section of 8-in.-wide
beam treated for depth of
carbonation

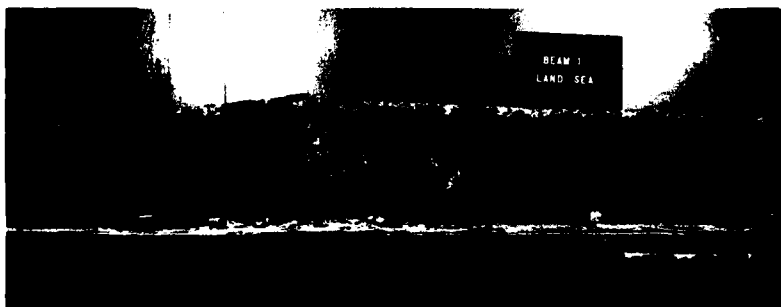
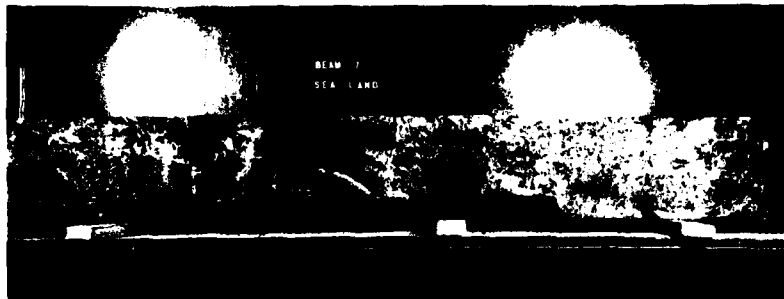
Note: In titles of Photos 3-22 the direction (east and west) refers to orientation at exposure station.

31. Photographs 3-22 show the "as received" condition of ten of the beams. The surfaces of the beams were still moist with sea-water when they were taken from the bituminous membrane, and they had not been subjected to any drying in transit. As can be seen in the photographs there was considerable spalling of the cover over the reinforcement. The spalled areas range in length from 1-1/2 in. long, where no reinforcement had been exposed to nearly the entire length of the beam, exposing the major amount of reinforcement. The spalls were deep enough to expose at least half of the bar and generally occurred in the area of the flexural cracks, although some spalls did occur at the ends of the beam away from the flexural areas.
